This consists of the following Bosch components:

3.1983
(Replaces Ed. 1.1982)

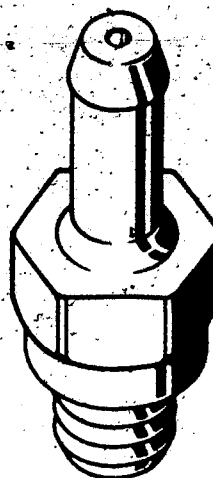
Fig. 2

Distributor-type fuel-injection pumps (VE) for Opel Kadett and Ascona Diesel are not fitted with overflow throttles (Fig. 1), but with overflow throttle fittings (Fig. 2 - Opel part).

Before testing and setting VE pumps, the overflow throttle fitting (Opel part) must be removed. To do this screw in the overflow throttle according to the service-parts microfiche (marked with "out") and test or set the pump with this. Finally exchange the Bosch overflow throttle again for the overflow throttle fitting (Opel part).

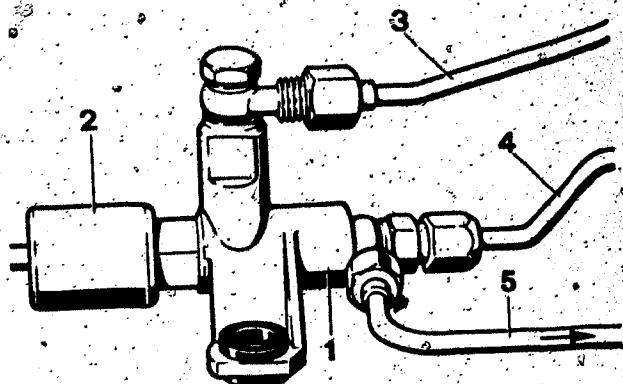
Fig. 2

The effect of a possible fault in the control-pressure reduction system should be borne in mind when troubleshooting in the vehicle (control-pressure testing, leak test on the overall system).

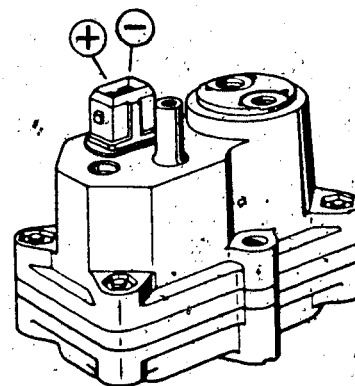
Fig. 6

In the case of warm-up regulators with a thermo-contact it is absolutely essential to ensure the correct polarity of the electric connector. Incorrect connection will cause irreparable damage to the thermo-contact.

On the 928/928 S vehicles of model years 1978 to 1980 the correct polarity is not specified. Therefore, this must be tested when installing the new warm-up regulators and must, if necessary, be corrected on the connector (+ to +, - to -).

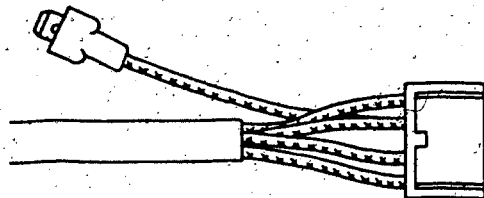
Connector of 0 390 236 001

When motor no. 0 390 236 001 is used up, only the new design .. 002 will be delivered. This also applies to replacement needs. If the vehicle was fitted with wiper motor no. .. 001, the plug connections must be adapted to suit the replacement motor .. 002.

To do this the cable with pin terminal coming out of the wiring harness of the new motor must be connected to the same-coloured cable which is free on the multiple plug (pink, terminal 53a). The pin terminal should be cut to make it slightly smaller.

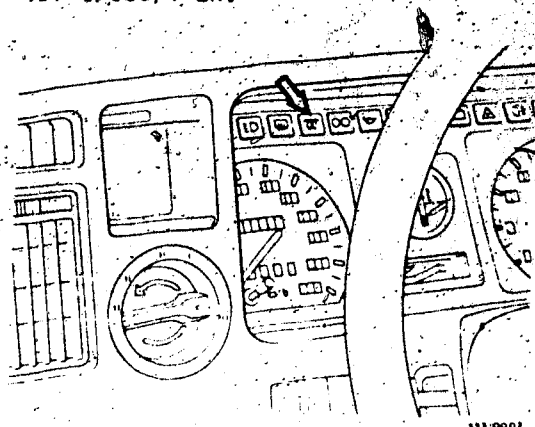
Fig. 1 Arrow = Start repeater lamp

2. In order to prevent the glow-duration unit from being irreparably damaged, the start repeater lamp must be fitted with a 12 V max. 2 W bulb.

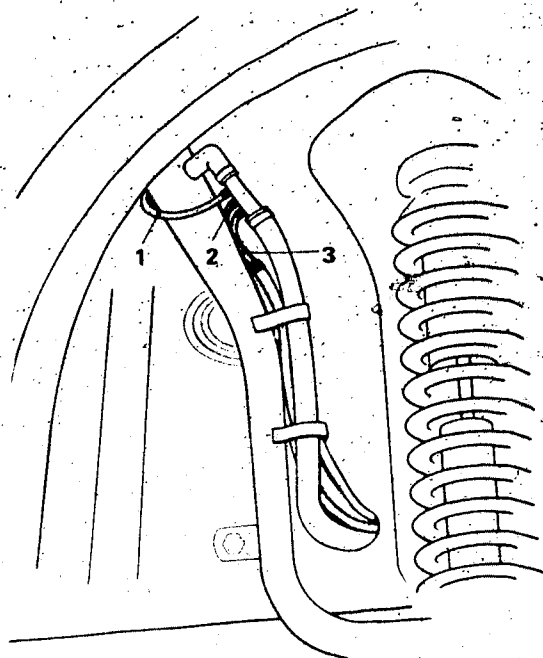
In these vehicles it can occur that the control plunger in the fuel distributor jams, due to corrosion or dirt. The result: starting troubles.

If the hoses have evidently been laid incorrectly, thus allowing water to penetrate into K-Jetronic components which have subsequently rusted and broken down, the warranty claim should be rejected.

Hose 1 must be laid as short as possible, but without tension. Lay hoses 2 and 3 between the fuel-tank filler fitting and the side of the bodywork. Shorten them if necessary.

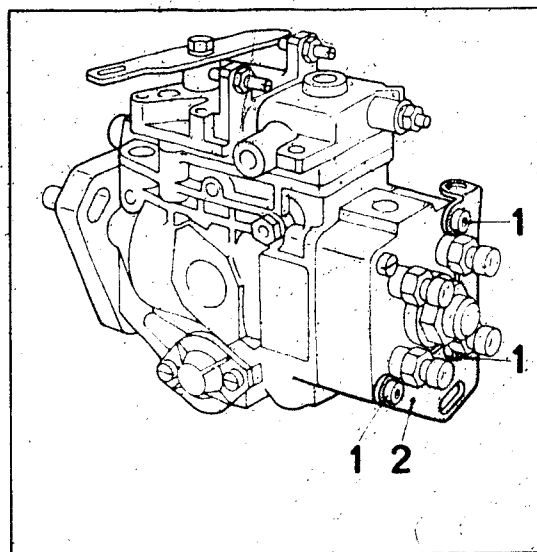
Fig. 2

It has become necessary for us point out that the fastening screws (Fig. 2, Pos. 1), are not to be loosened or removed when the pump is removed. These screws serve to fasten the hydraulic head. Loosening or removal can cause the pump plunger to tilt, and this can result in plunger breakage.

The same number of shims must be fitted under the support plate (Fig. 2, Pos. 2) for each of the 3 hexagon-socket-head cap screws (Fig. 2, Pos. 1).

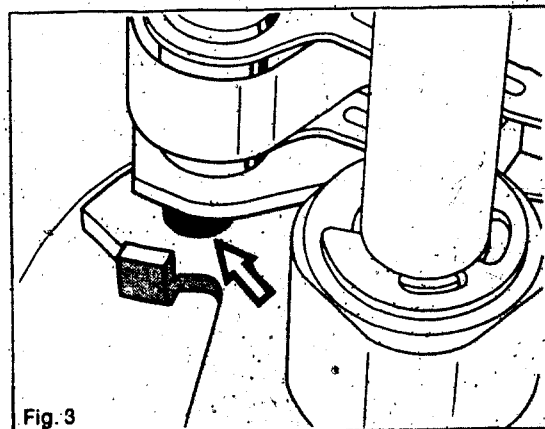
In Fig. 3 (arrow) the bearing pin has not slipped in. Carry out a visual check.
